**ANNUAL SURFACE IMPOUNDMENT INSPECTION REPORT
LUMINANT – MONTICELLO STEAM ELECTRIC STATION
BOTTOM ASH PONDS
TITUS COUNTY, TEXAS**

January 15, 2016

PBW Project No. 2178A

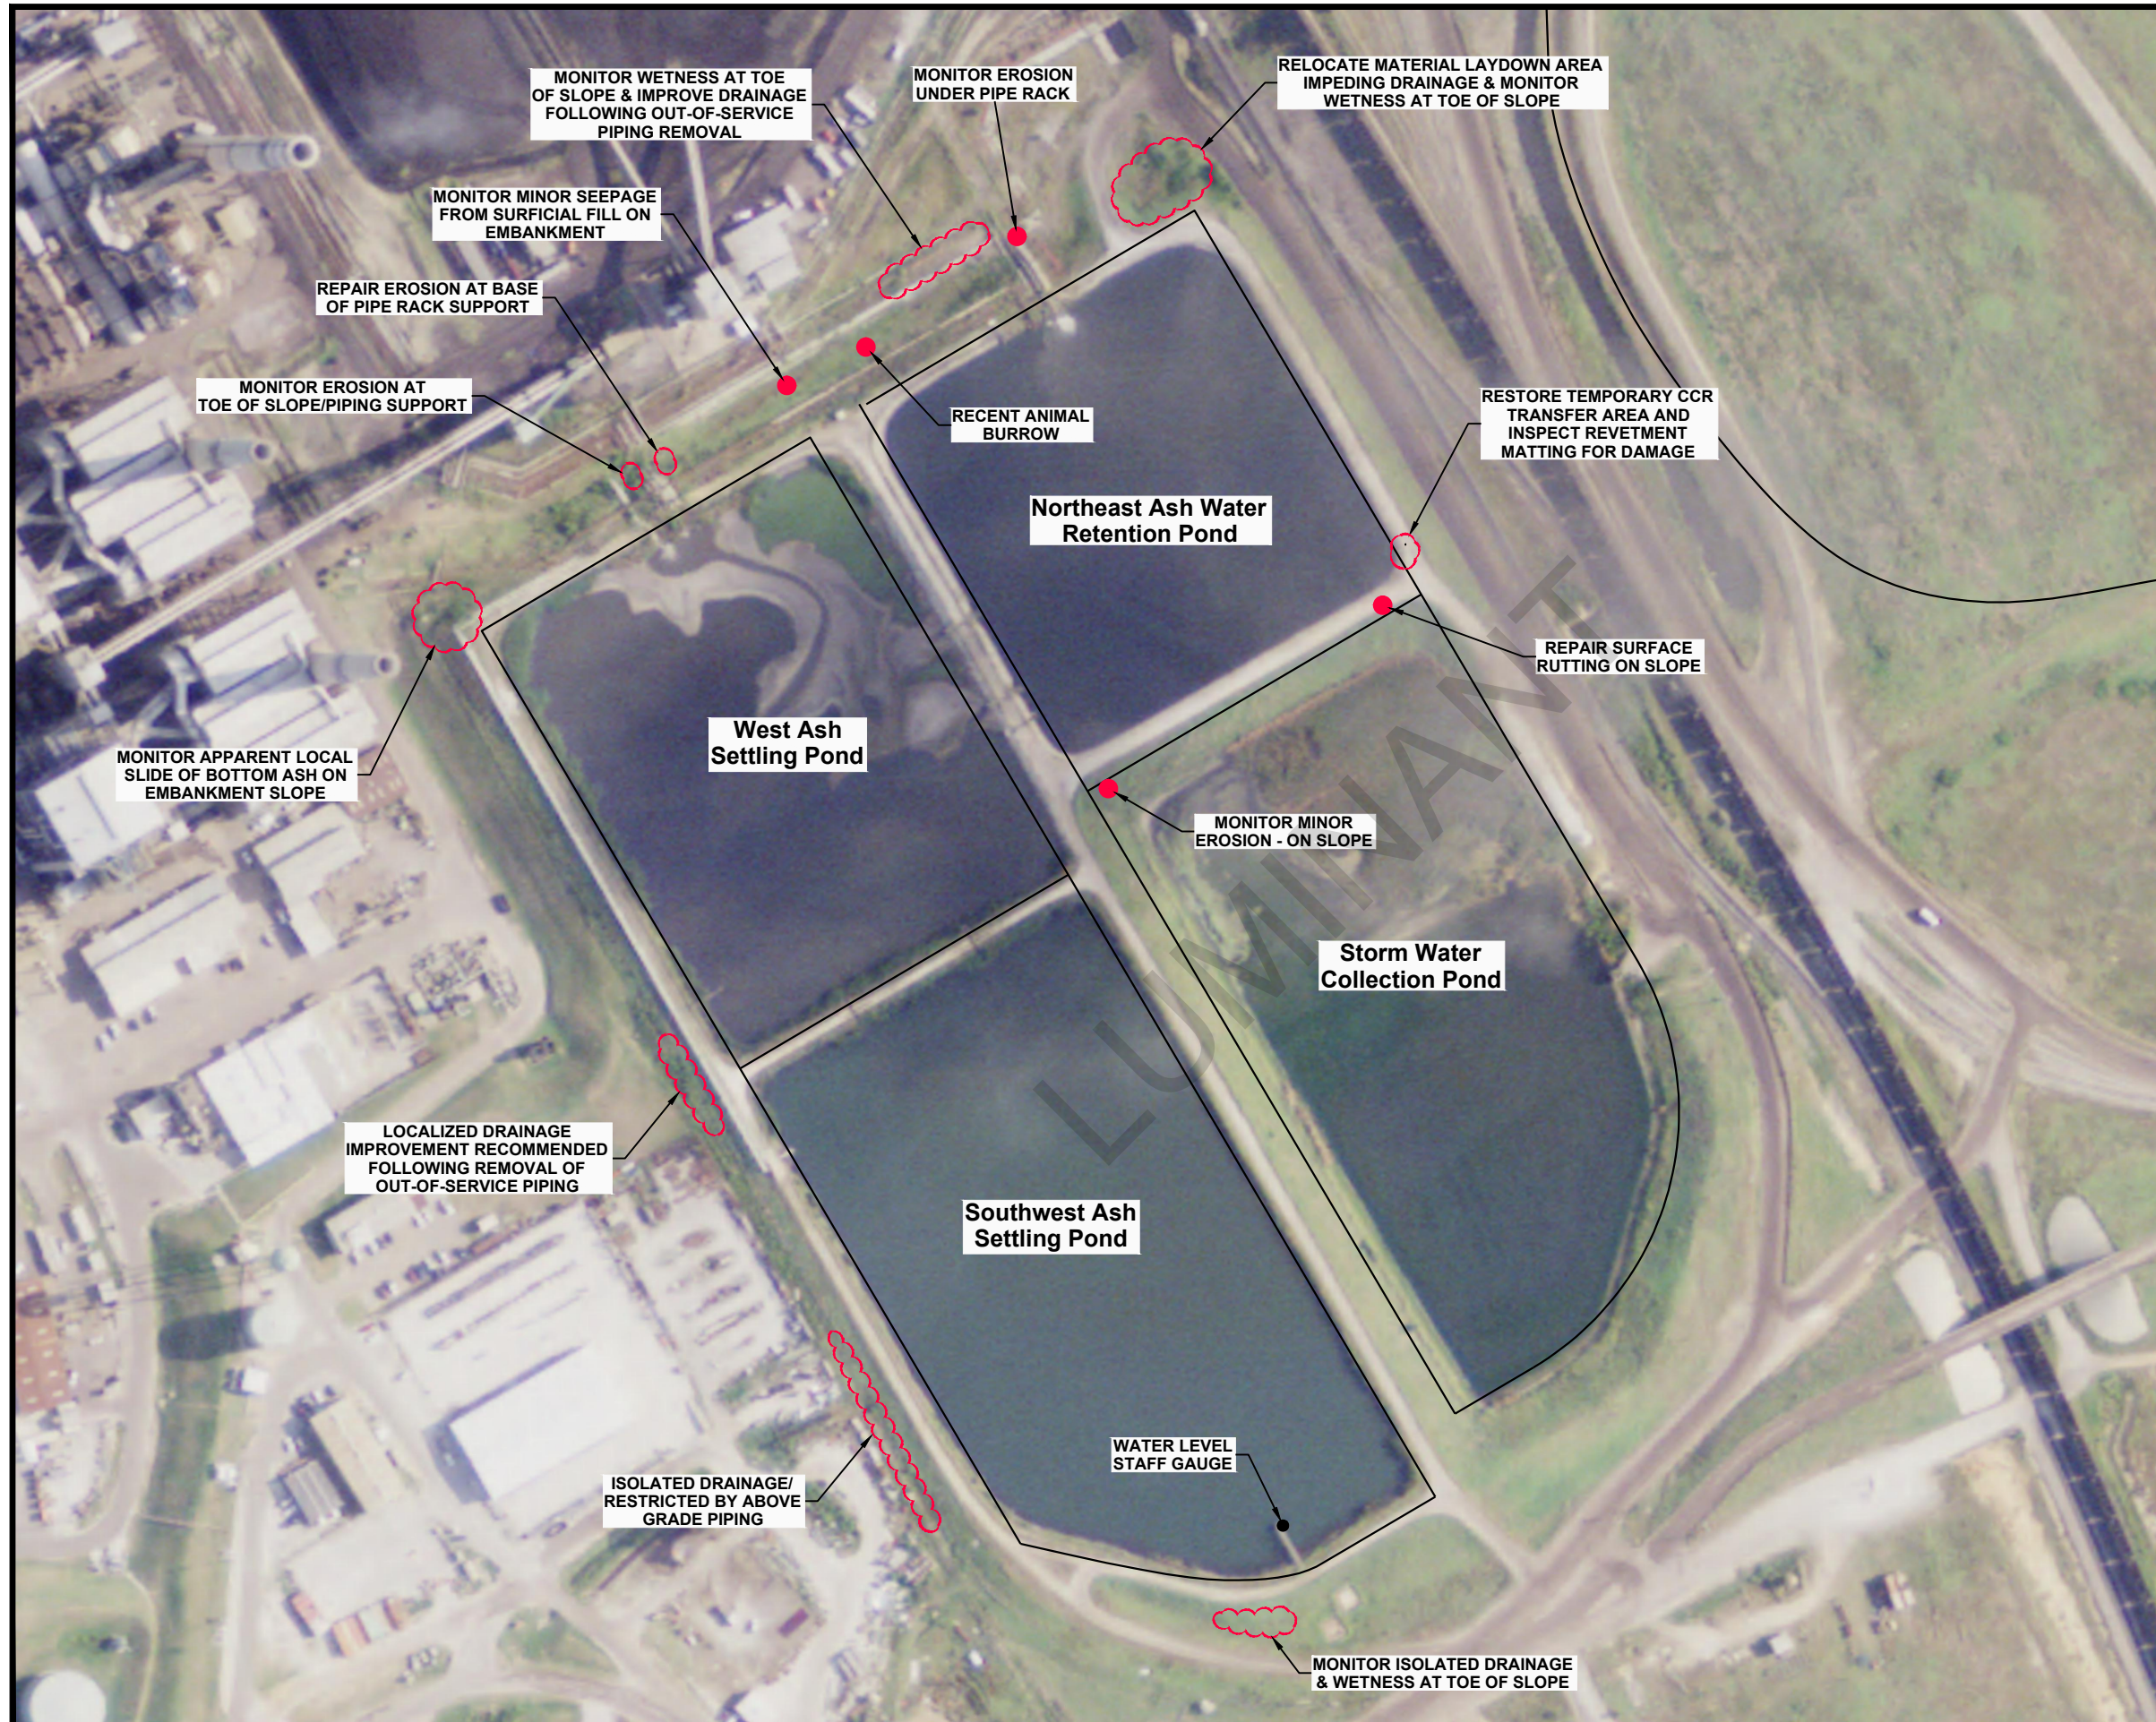
Figure 3

The downstream embankments of the BAPs were generally in good condition and no visual evidence or slope movement or misalignment was noted during the inspection. With exception of areas along the north and west sides of the West Pond, the embankments were well vegetated with grasses that have been mowed to a height of less than 6-inches. The apparent beneficial use of bottom ash as fill was observed along the piping corridor on the west embankment of the West Pond. Although the relatively short slope lengths in this area have limited erosion of fill on the embankment, topsoil should be placed over this portion of the embankment to ensure adequate vegetative cover is maintained. Similar conditions were noted near the northwest corner of the West Pond; however, a former localized slope failure was noted on the surficial bottom ash placed on the slope in this area (Appendix A; Photograph 4). The interior embankment materials (e.g. clayey fill) are not exposed in this area, and the localized feature does not pose a significant threat to the structural integrity of the embankment. As indicated on Figure 3, the following areas were noted for future monitoring or repair:

- Repair erosion undermining the pipe rack footing on the north side of the West Pond.
- Repair surficial rutting on the slope near the southeast corner of the NE Pond.
- Monitor wet conditions near the toe of the embankments at the following locations (Note - Minor re-grading may improve drainage near the embankment toe in these areas):
 - South of the SW Pond
 - Northwest of the NE Pond along the piping corridor; and
 - Near the northeast corner of the NE Pond.
- Transfer piping impairs drainage relief near the embankment toe on the west side of both the SW Pond and West Pond as well as on the north side of the NE Pond. If removal of out-of-service piping is practicable, these areas should be re-graded to improve drainage. Otherwise

- Continue monitoring an apparent slope failure near the northeast corner of the West Pond. This area of slope instability appears related to the presence of bottom ash placed on the original embankment slope as part of an extension of the embankment to allow for placement of a piping corridor. Hence, continued monitoring is sufficient to ensure current conditions remain stable and the underlying original embankment materials remain stable.
- Monitor areas of localized erosion near the influent pipe rack to the West Pond, under the influent pipe rack for the NE Pond, and on the slope near the southwest corner of the NE Pond.

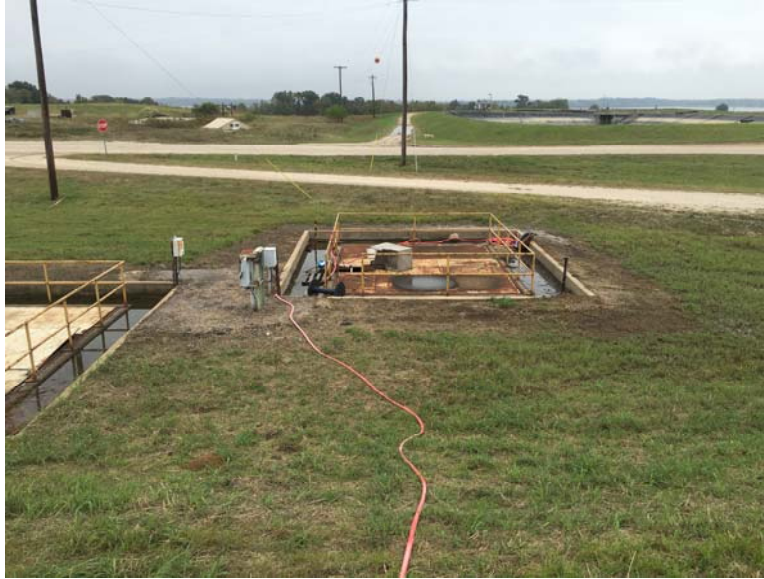
Pastor, Behling & Wheeler	DESCRIPTION	Photograph 1 – (View SE) Concrete collection chamber for inactive SW Pond dewatering system.	
PROJECT NO. 5178-A	SITE NAME	Monticello Steam Electric Station– Annual Surface Impoundment Inspection	DATE 11/3/2015

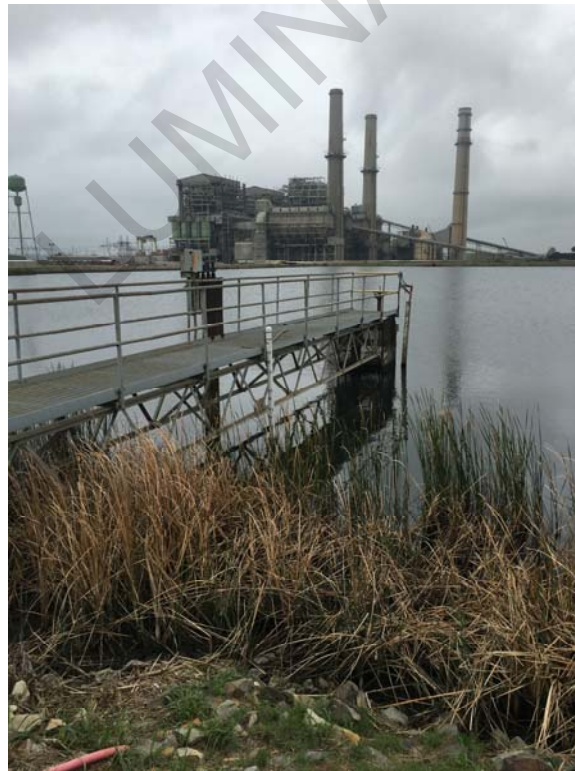
Pastor, Behling & Wheeler	DESCRIPTION	Photograph 2 – (View NW) SW Pond pier/manway with staff plate visible.	
PROJECT NO. 5178-A	SITE NAME	Monticello Steam Electric Station– Annual Surface Impoundment Inspection	DATE 11/3/2015

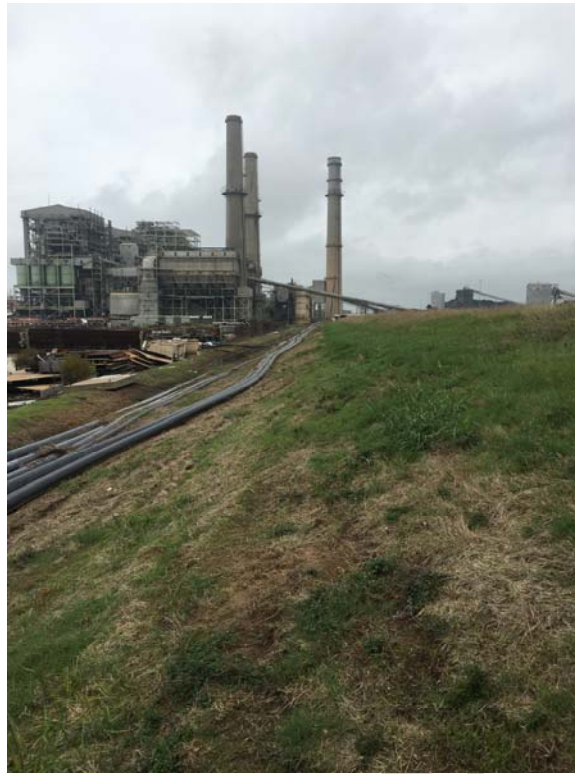
Pastor, Behling & Wheeler	DESCRIPTION	Photograph 3 – (View NW) Downstream embankment of SW Pond with piping at toe. Monitor wet areas and improve drainage following out-of-service piping removal.	
PROJECT NO. 5178-A	SITE NAME	Monticello Steam Electric Station– Annual Surface Impoundment Inspection	DATE 11/3/2015

wet soil conditions should be monitored to ensure the areas dry fully during seasonally dry periods. Growth of woody vegetation should also be controlled in these areas to ensure sufficient visibility for inspection and minimize potential impacts to slope stability.

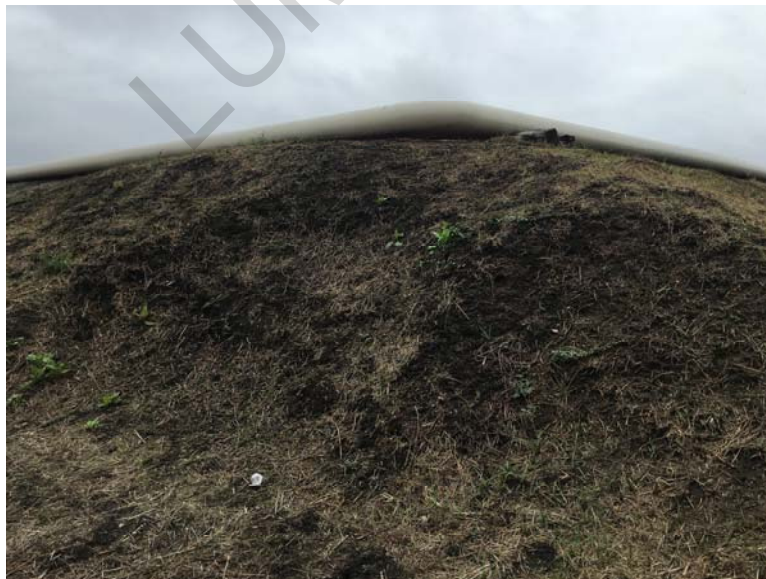
Pastor, Behling & Wheeler	DESCRIPTION	Photograph 4 – (View SE) Apparent local slope failure of bottom ash placed over original embankment material at northwest corner of West Pond.	
PROJECT NO. 5178-A	SITE NAME	Monticello Steam Electric Station– Annual Surface Impoundment Inspection	DATE 11/3/2015

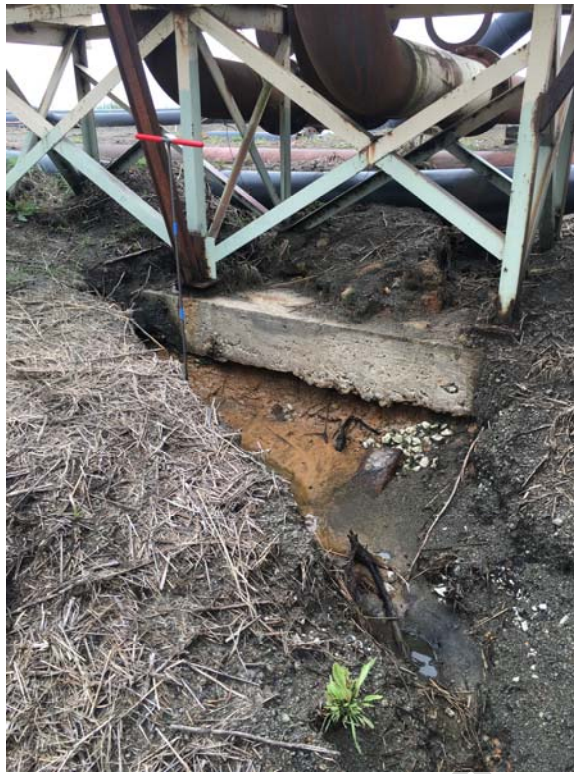
Pastor, Behling & Wheeler PROJECT NO. 5178-A	DESCRIPTION	Photograph 5 – (View SE) Erosion undermining footing for pipe rack support on north embankment of West Pond.	
	SITE NAME	Monticello Steam Electric Station– Annual Surface Impoundment Inspection	DATE 11/3/2015

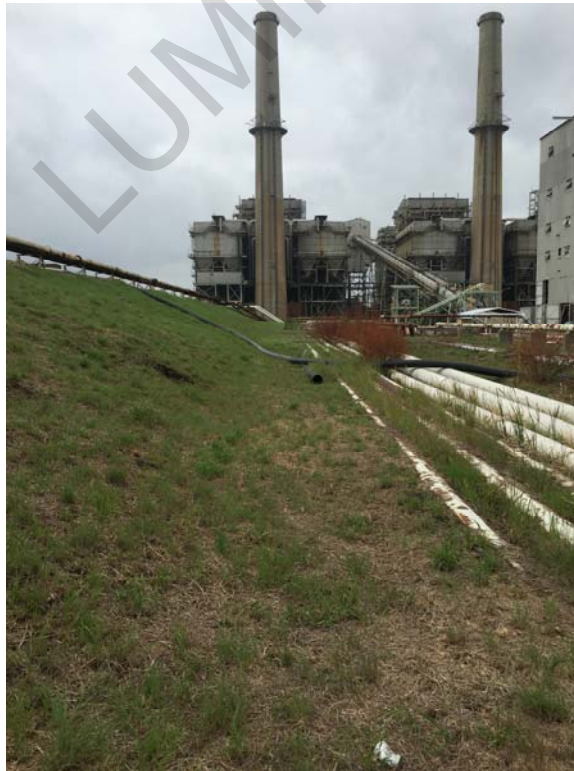
Pastor, Behling & Wheeler PROJECT NO. 5178-A	DESCRIPTION	Photograph 6 – (View SW) Piping corridor at toe of NE Pond embankment. Piping impedes toe drainage, monitor wet conditions.	
	SITE NAME	Monticello Steam Electric Station– Annual Surface Impoundment Inspection	DATE 11/3/2015

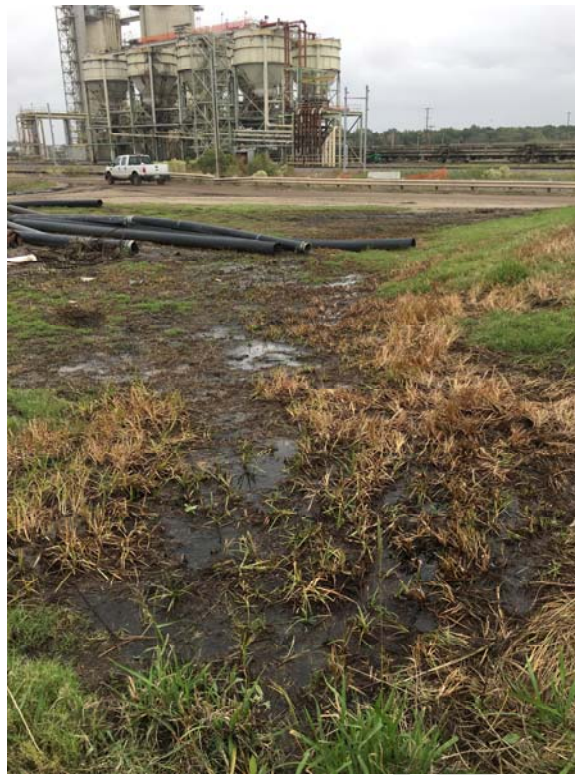
Pastor, Behling & Wheeler	DESCRIPTION	Photograph 7 – (View NE) Wet area at toe of NE Pond embankment. Remove material laydown area and improved drainage.	
PROJECT NO. 5178-A	SITE NAME	Monticello Steam Electric Station– Annual Surface Impoundment Inspection	DATE 11/3/2015

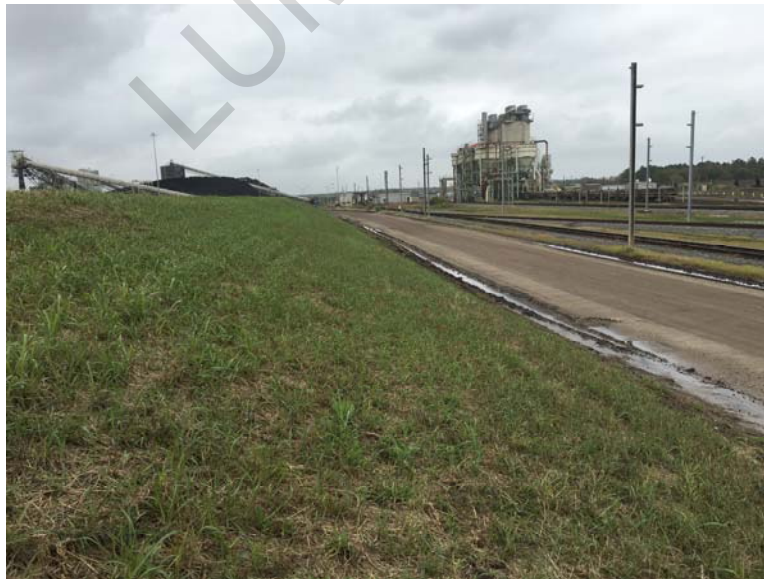
Pastor, Behling & Wheeler	DESCRIPTION	Photograph 8 – (View NW) View of Eastern embankment of NE Pond.	
PROJECT NO. 5178-A	SITE NAME	Monticello Steam Electric Station– Annual Surface Impoundment Inspection	DATE 11/3/2015

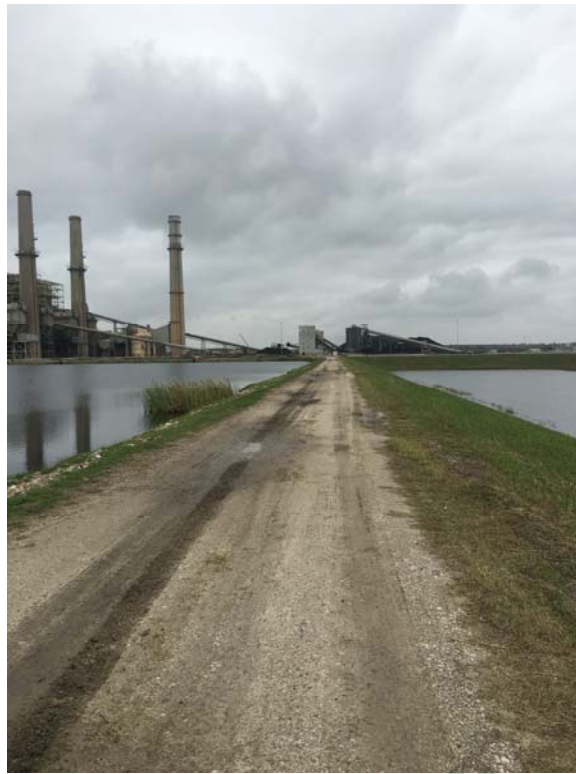
Pastor, Behling & Wheeler	DESCRIPTION	Photograph 9 – (View NW) Crest of SW Pond embankment with storm water collection pond visible at right.	
PROJECT NO. 5178-A	SITE NAME	Monticello Steam Electric Station– Annual Surface Impoundment Inspection	DATE 11/3/2015

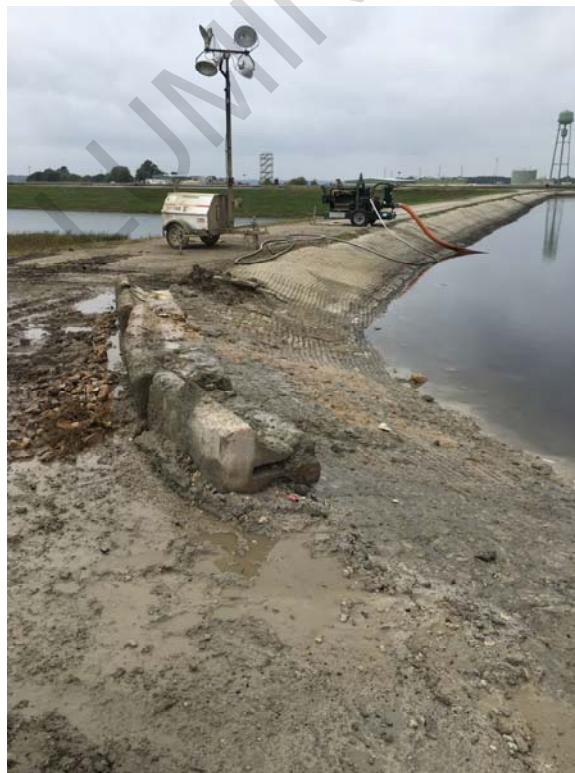
A temporary CCR transfer area has been designated near the southeast corner of the NE Pond, and transport trucks are currently backed into place to discharge loads of CCR in to the NE Pond (Appendix A; Photograph 10). This temporary transfer area is underlain with a liner and surface runoff is

Pastor, Behling & Wheeler	DESCRIPTION	Photograph 10 – (View SW) Temporary CCR transfer area NE Pond.	
PROJECT NO. 5178-A	SITE NAME	Monticello Steam Electric Station– Annual Surface Impoundment Inspection	DATE 11/3/2015

towards the NE Pond. Concrete barriers are present to prevent haulage equipment from backing onto the revetment matting. Upon ceasing transfer of CCR in this area, the area should be restored and the revetment matting should be inspected for potential damage from vehicular traffic.

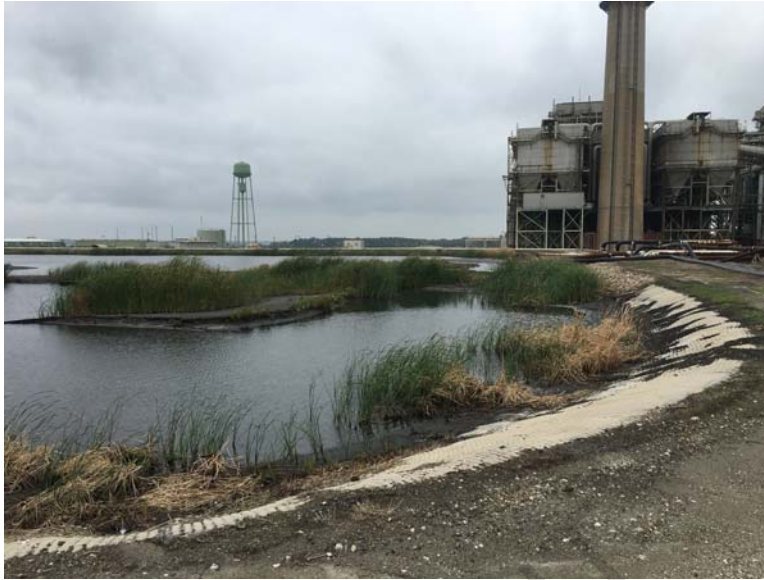
Pastor, Behling & Wheeler	DESCRIPTION	Photograph 11 – (View SW) View of West Pond with influent piping at right.	
PROJECT NO. 5178-A	SITE NAME	Monticello Steam Electric Station– Annual Surface Impoundment Inspection	DATE 11/3/2015

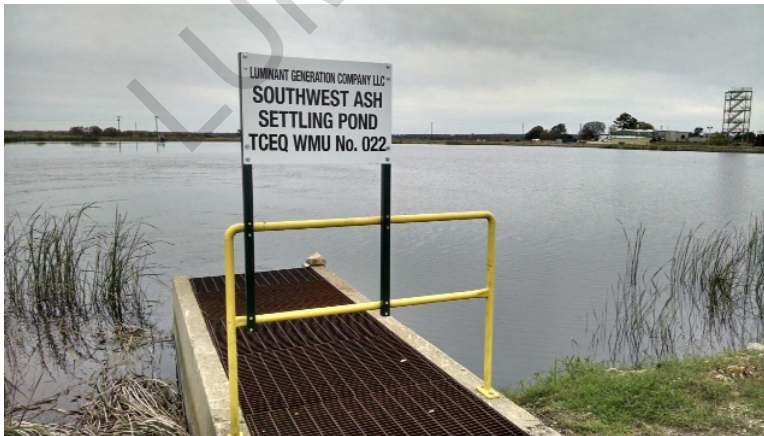
Pastor, Behling & Wheeler	DESCRIPTION	Photograph 12 – (View SE) Concrete-lined open channel connection between West and SW Ponds.	
PROJECT NO. 5178-A	SITE NAME	Monticello Steam Electric Station– Annual Surface Impoundment Inspection	DATE 11/3/2015
