**ANNUAL INSPECTION BY A QUALIFIED PROFESSIONAL ENGINEER**  
**40 CFR § 257.83(b)**

Site Name & Address	Former Wood River Power Station Madison County, Illinois 62017
Date of Inspection	12/30/2020
Operator Name/ Address	CTI Development, LLC 2275 Cassens Drive, Suite 118 Fenton, MO 63026
CCR Unit	East Ash Pond

**DATE OF INSPECTION: 12/30/2020**

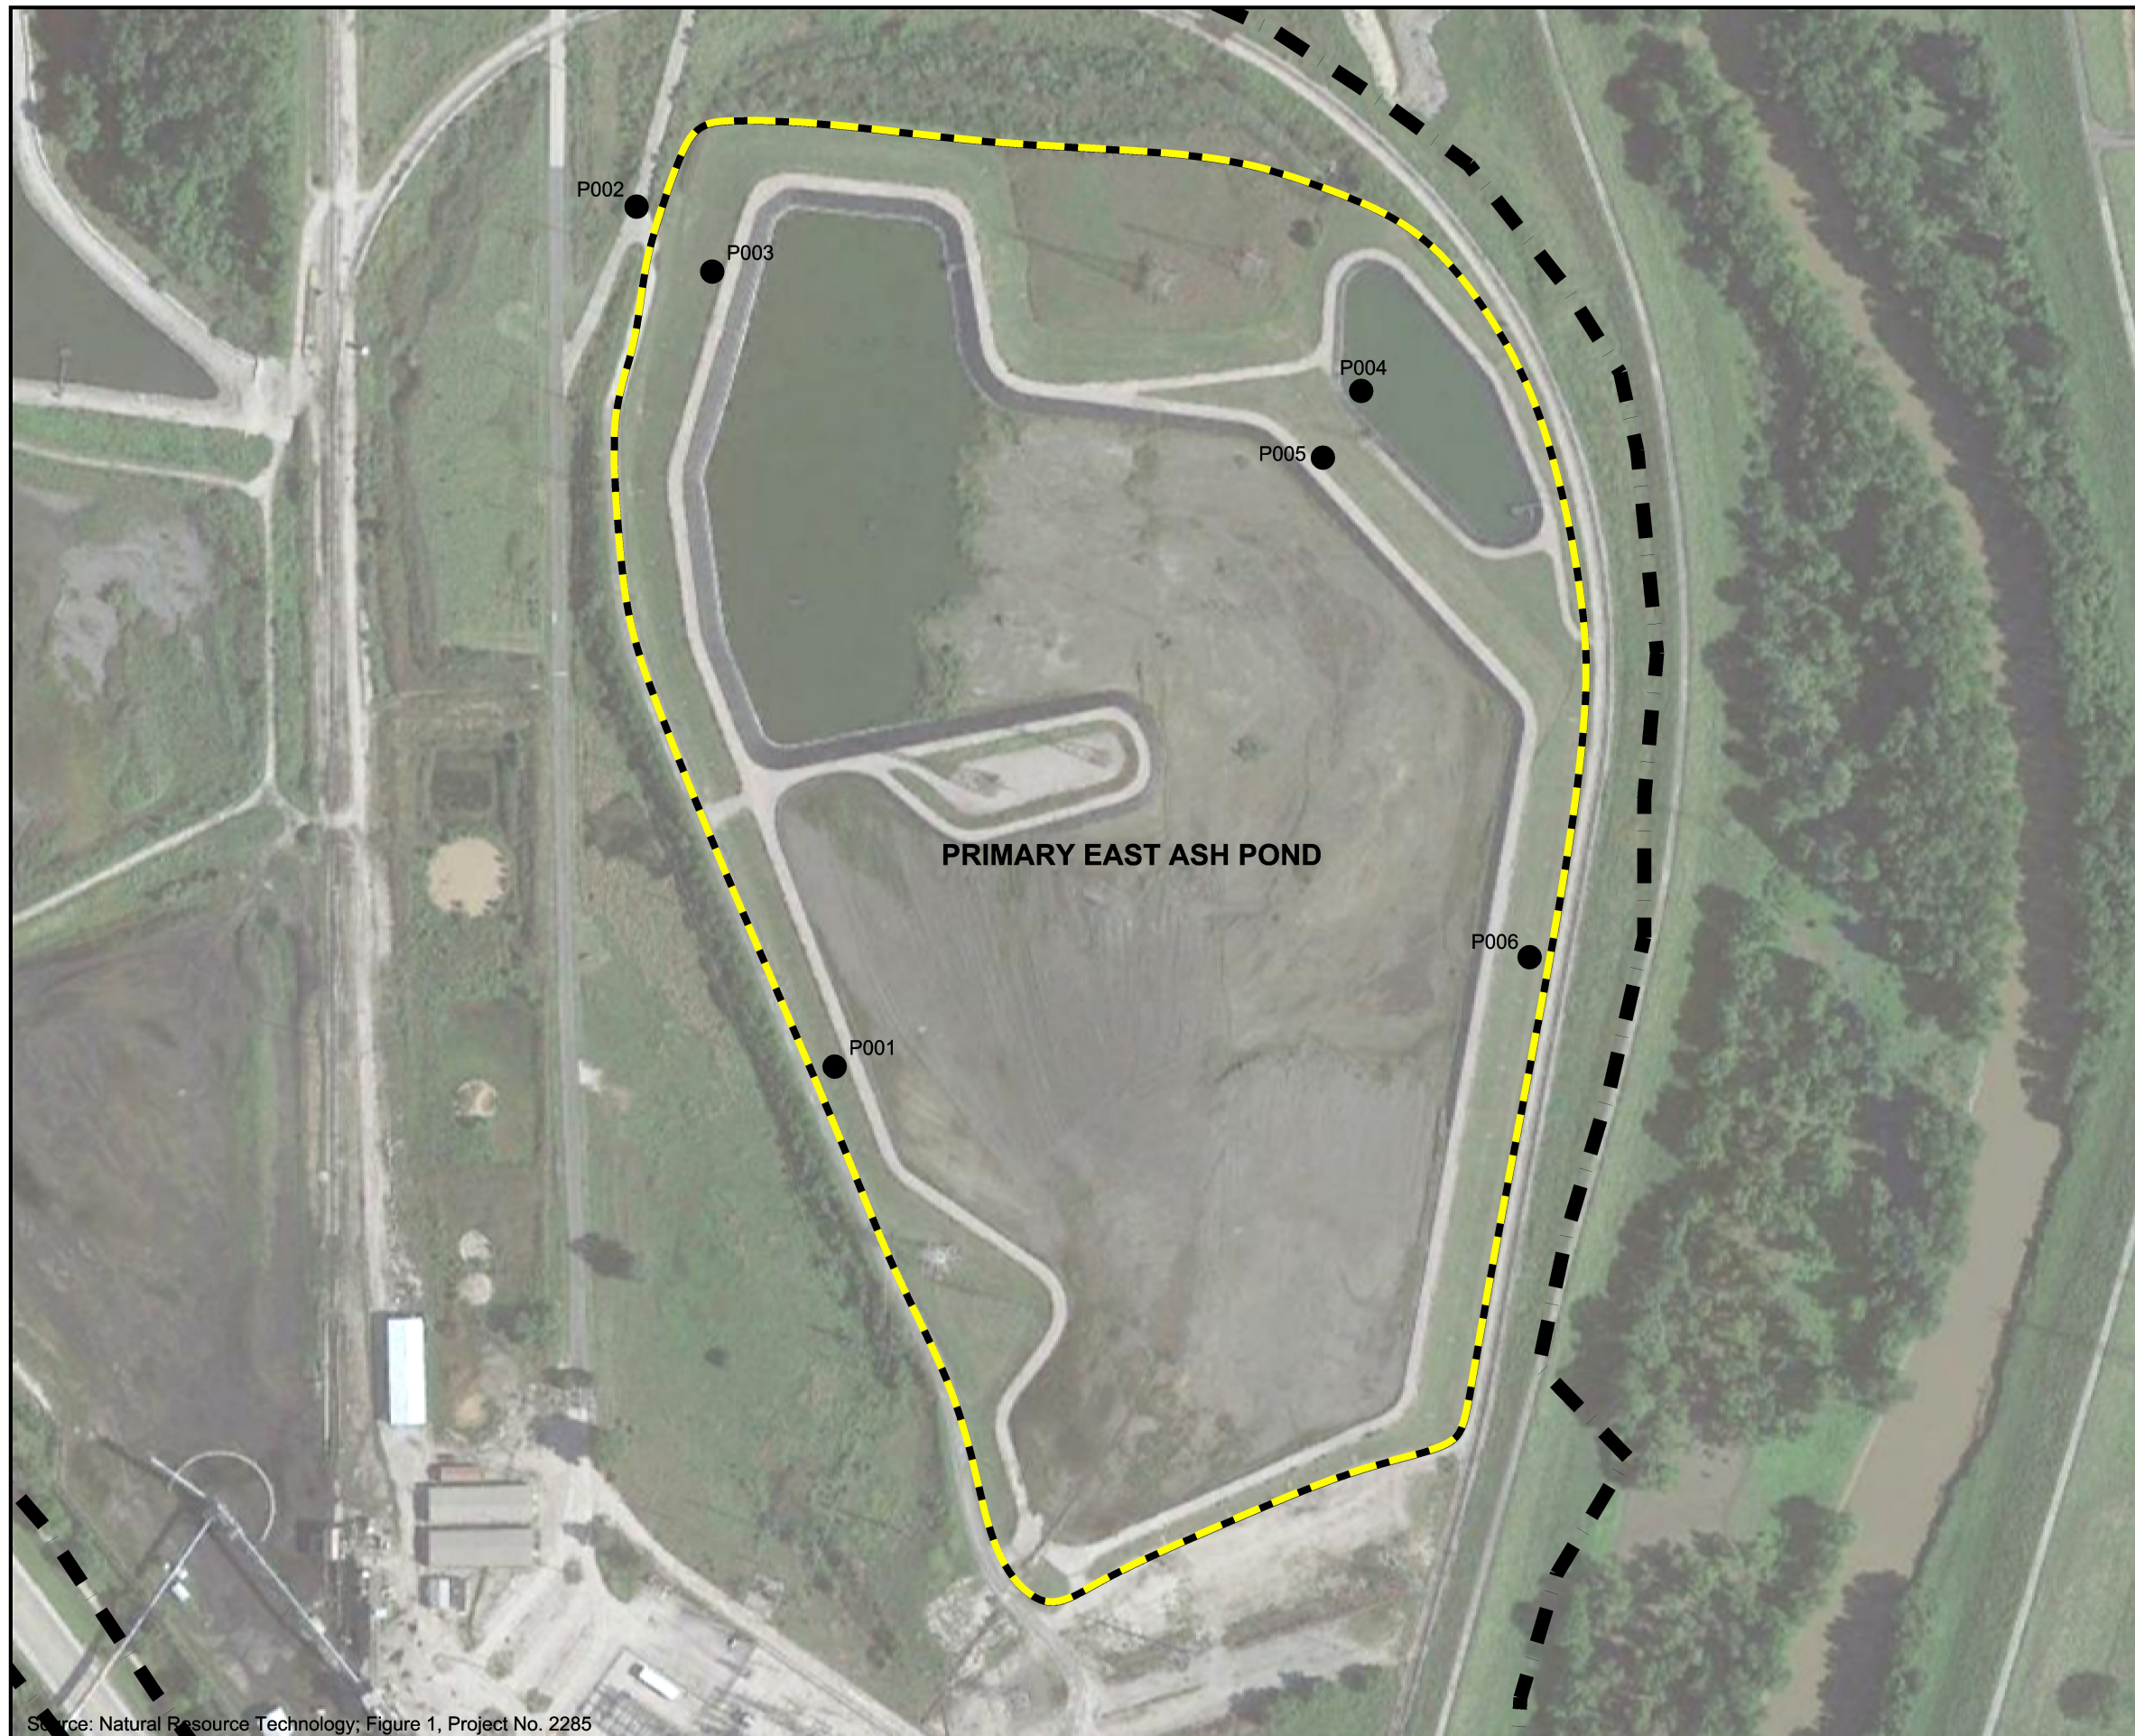
FIGURE  
 PRIMARY EAST ASH POND PIEZOMETER MAP  
 WOOD RIVER, FORMER DYNEGY  
 Alton, IL

Instrument ID#	Type	Maximum recorded reading since previous annual inspection (ft)
P001	Piezometer	426.7
P002	Piezometer	421.9
P003	Piezometer	424.7
P004	Piezometer	426.7
P005	Piezometer	426.1
P006	Piezometer	417.7
