**ANNUAL INSPECTION BY A QUALIFIED PROFESSIONAL ENGINEER**  
**40 CFR § 257.83(b)**

Site Name & Address	Former Wood River Power Station Madison County, Illinois 62017
Date of Inspection	12/30/2020
Operator Name/ Address	CTI Development, LLC 2275 Cassens Drive, Suite 118 Fenton, MO 63026
CCR Unit	West Ash Pond 1

**DATE OF INSPECTION: 12/30/2020**

**SITE NAME: CTI Development, LLC (Formerly Wood River Power Station)**  
**CCR UNIT: West Ash Pond 1**

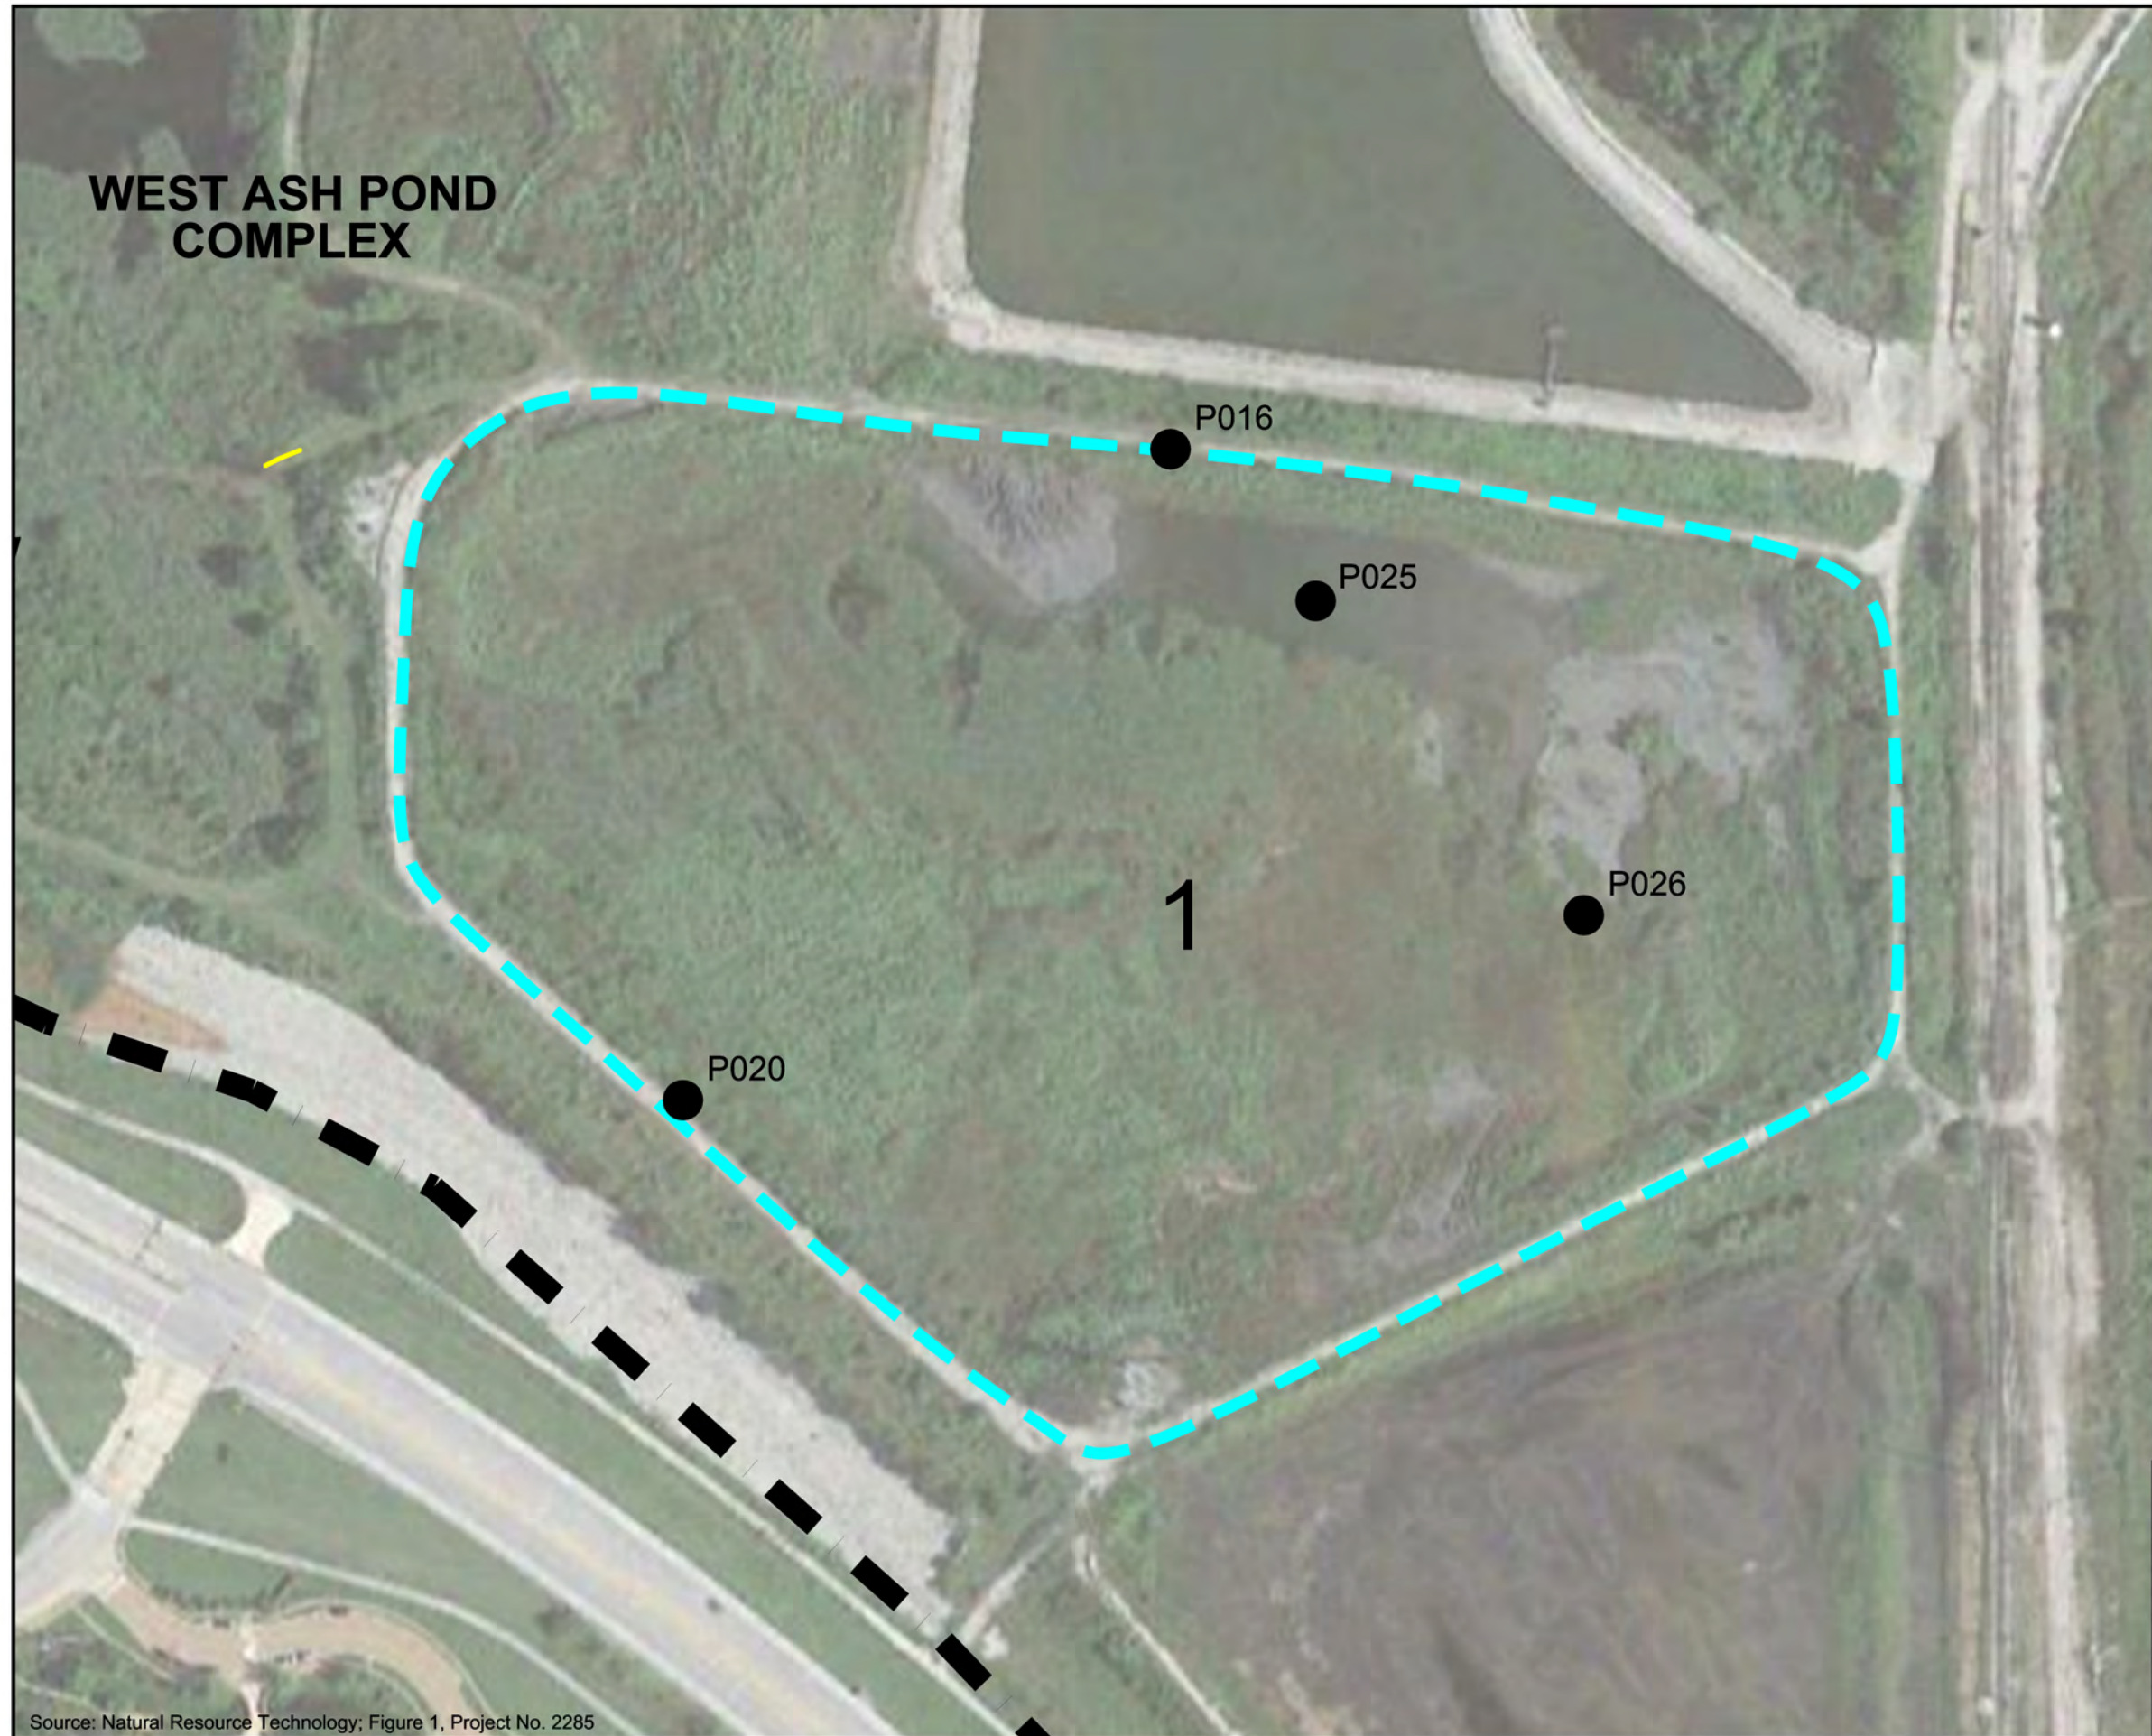
FIGURE  
WEST POND 1 PIEZOMETER MAP  
WOOD RIVER, FORMER DYNEGY  
Alton, IL

Instrument ID#	Type	Maximum recorded reading since previous annual inspection (ft)
P016	Piezometer	N/A
P020	Piezometer	422.9
P025	Piezometer	431
P026	Piezometer	431.1

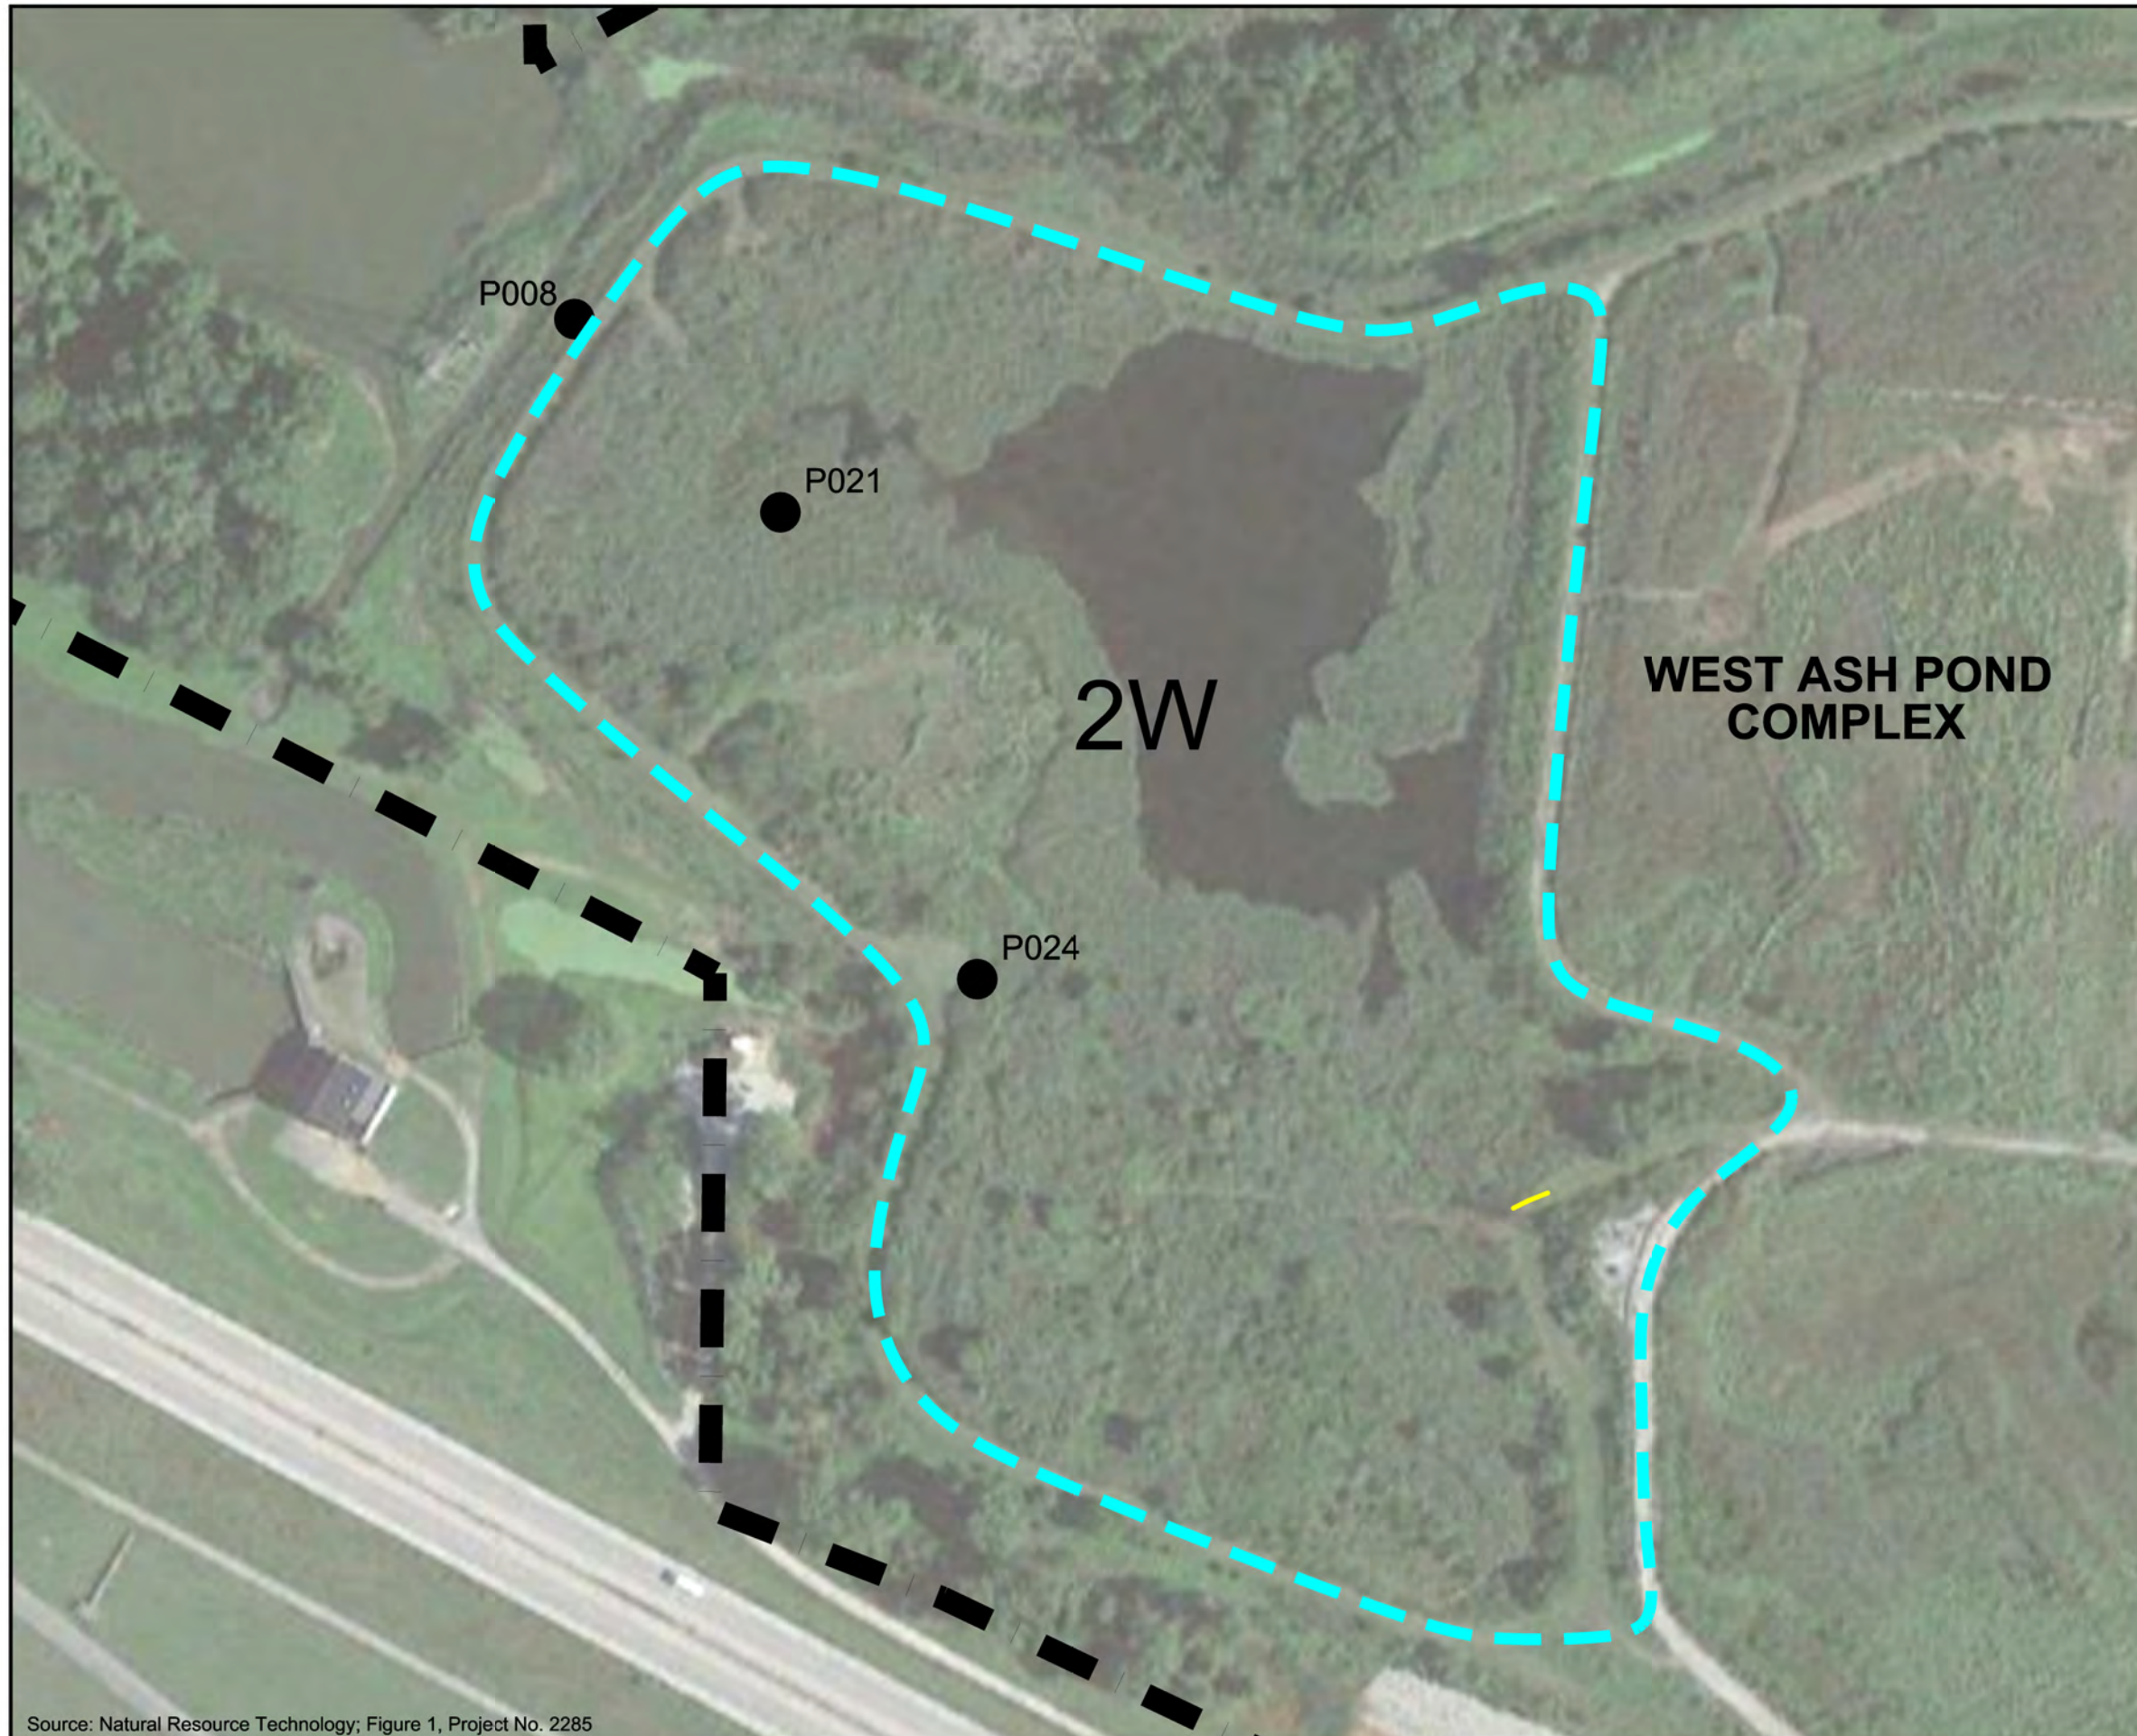
FIGURE  
WEST POND 2W PIEZOMETER MAP  
WOOD RIVER, FORMER DYNEGY  
Alton, IL

Instrument ID#	Type	Maximum recorded reading since previous annual inspection (ft)
P008	Piezometer	411.5
P021	Piezometer	411.8
P024	Piezometer	412.8
