Documentation of Initial
Hazard Potential
Classification
Assessment

East Fly Ash Pond System
Havana Power Station
Mason County, Illinois

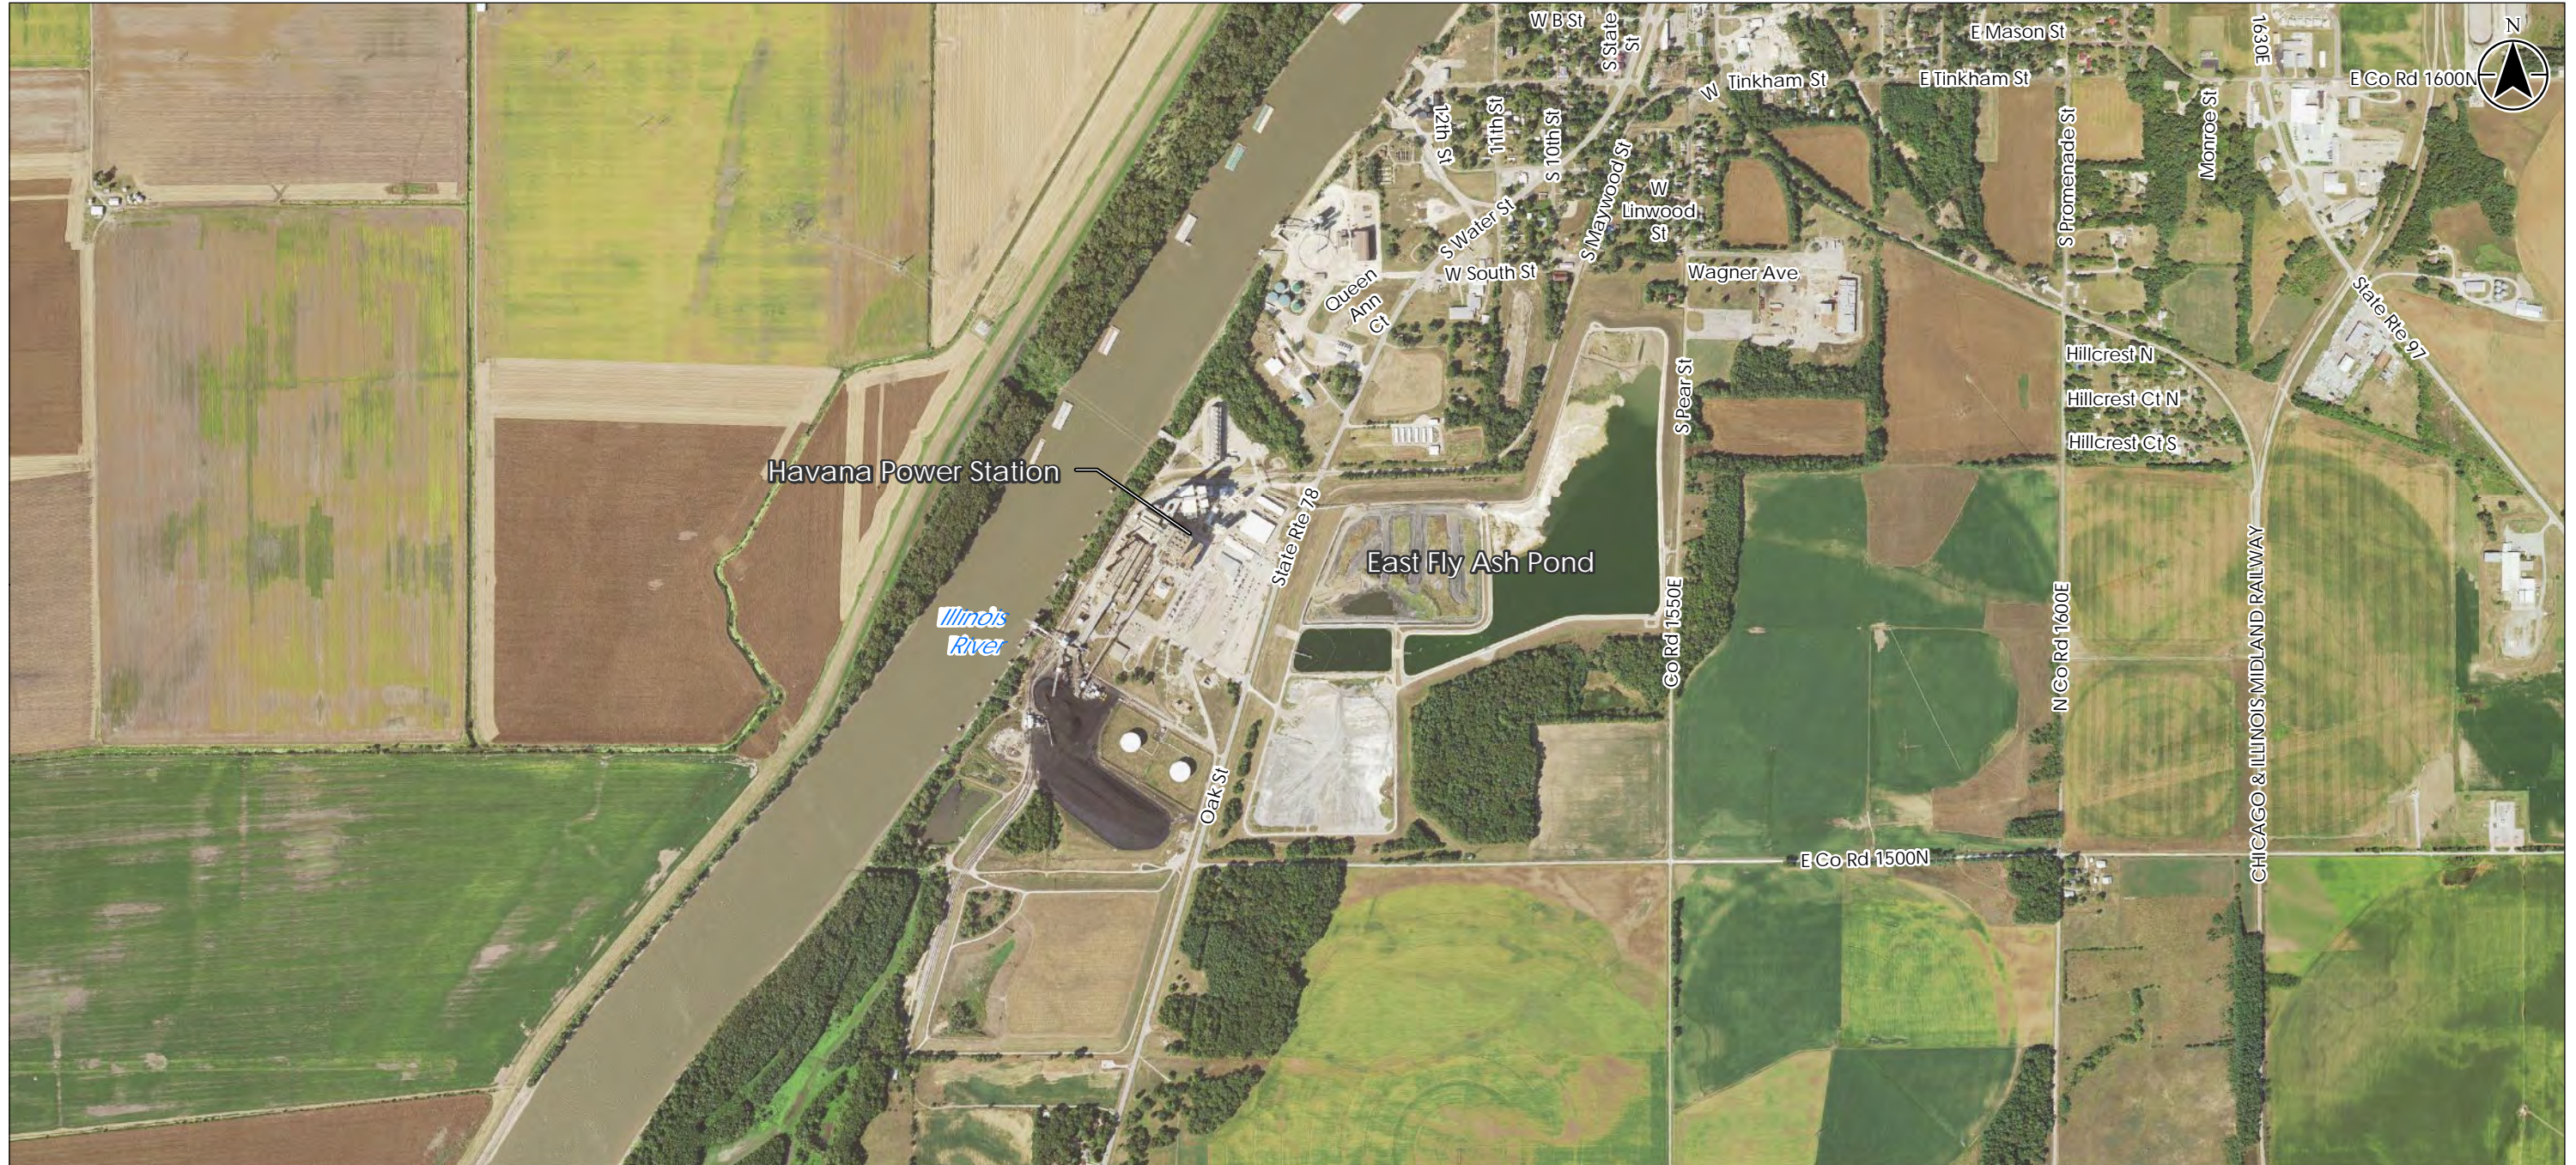
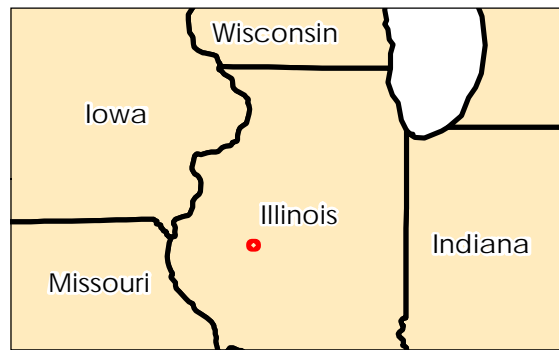
Site Overview Figure

Project Location 175605019
 Latitude: 40.280785 Prepared by WSW on 2016-10-05
 Longitude: -90.078625 Technical Review by NS on 2016-10-05
 Mason County, Illinois Independent Review by MH on 2016-10-05
