**ANNUAL CCR SURFACE IMPOUNDMENT
INSPECTION REPORT (per 40 CFR 257.83(b)(2))**

Power Station: Wood River Power Station

CCR Impoundment: West Ash Pond 2W

Date of Inspection: 8/22/2016

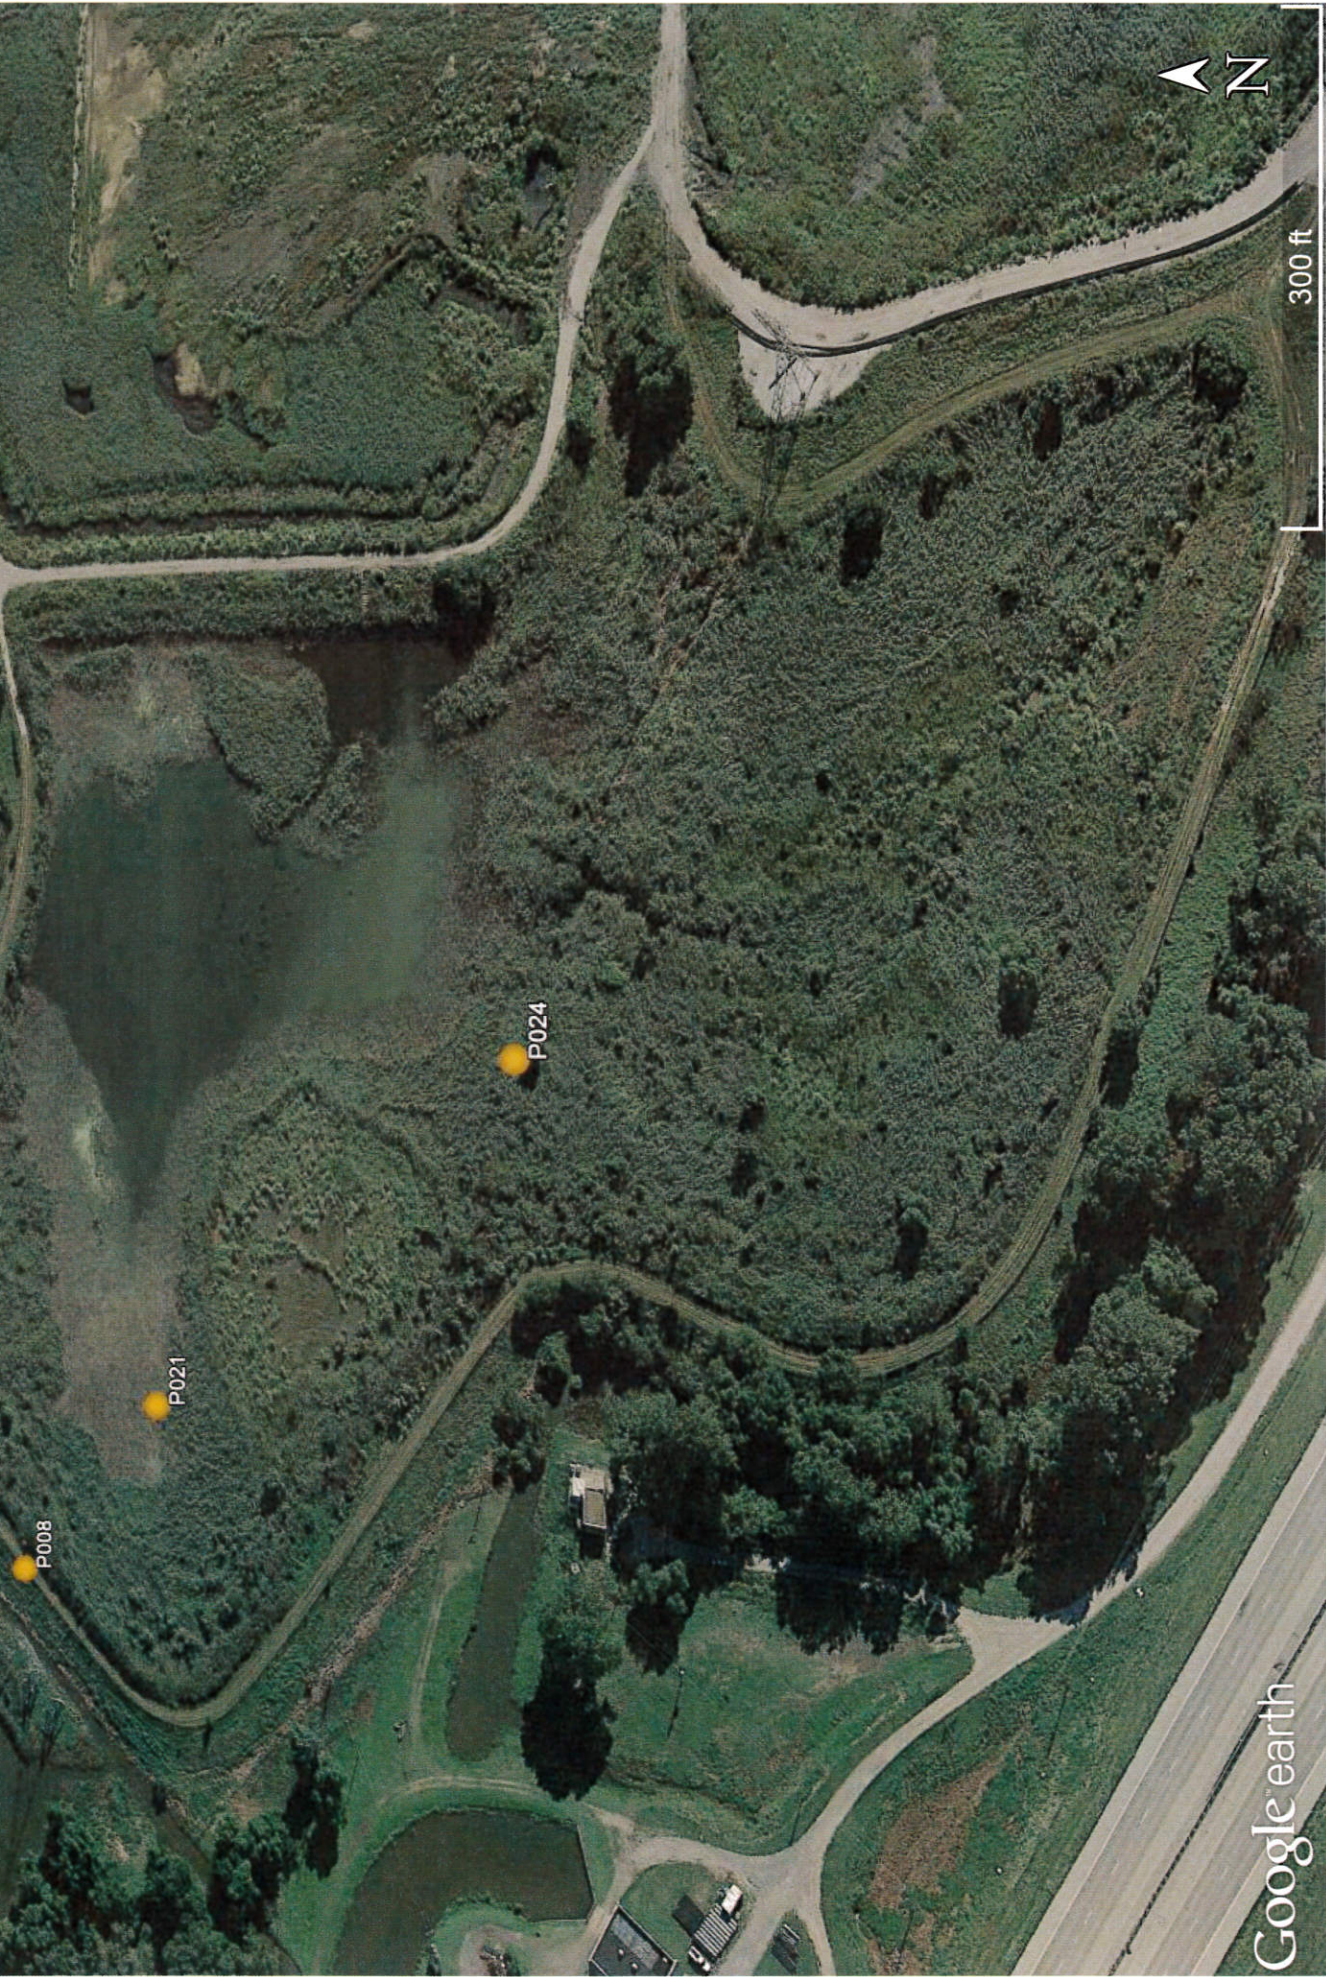
West Ash Pond 2W

- ii) Instrumentation
(Please see following page for instrumentation location map)
